Forested Wetland Restoration

Jake Robinson
Yankee Creek Forestry

South Slough National
Estuarine Research Reserve

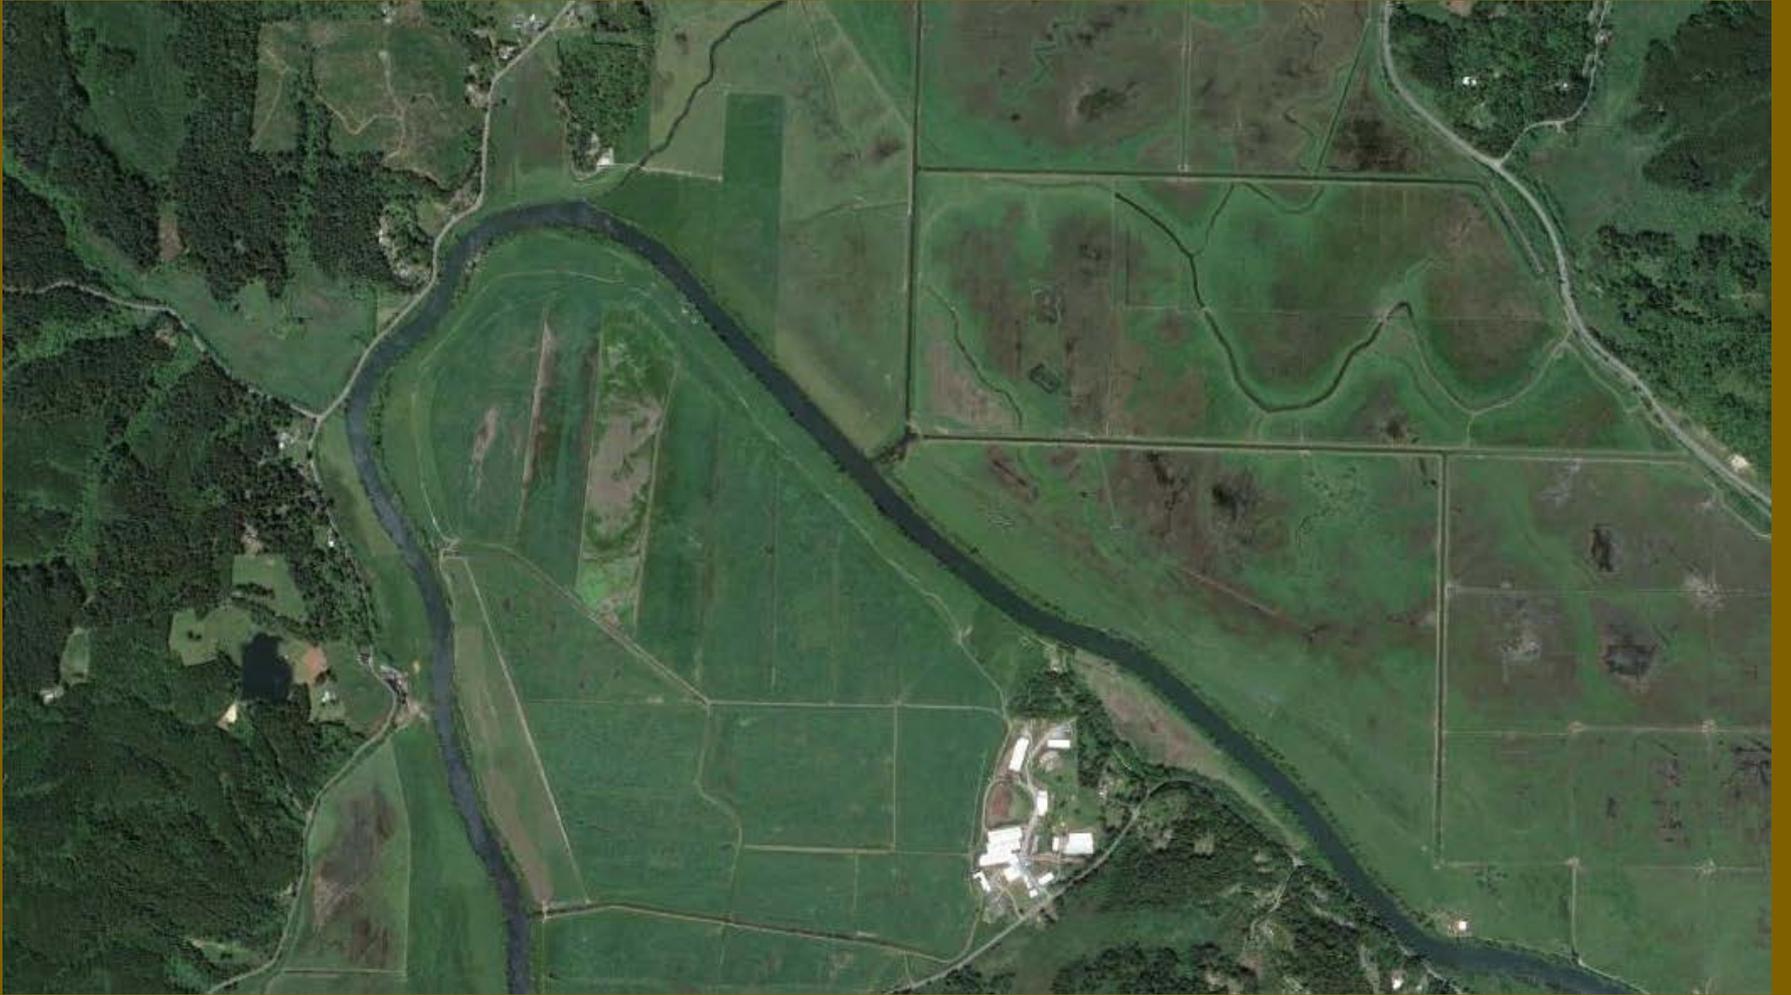
2 acre wetland, S side of Beaver Hill Rd. Connected to main wetland via 24" culvert. Main wetland in NRCS CREP, no tide gate to Coquille

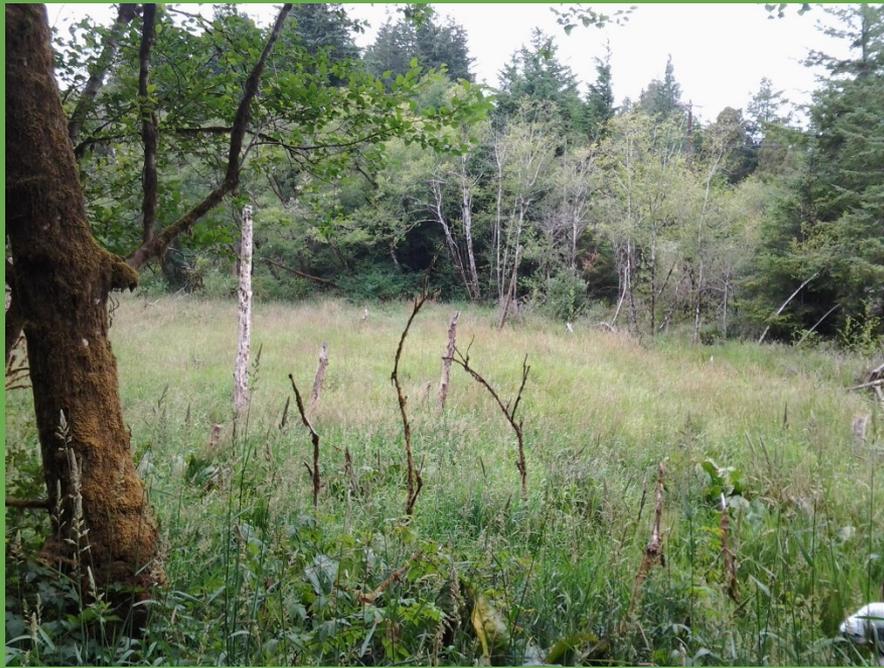
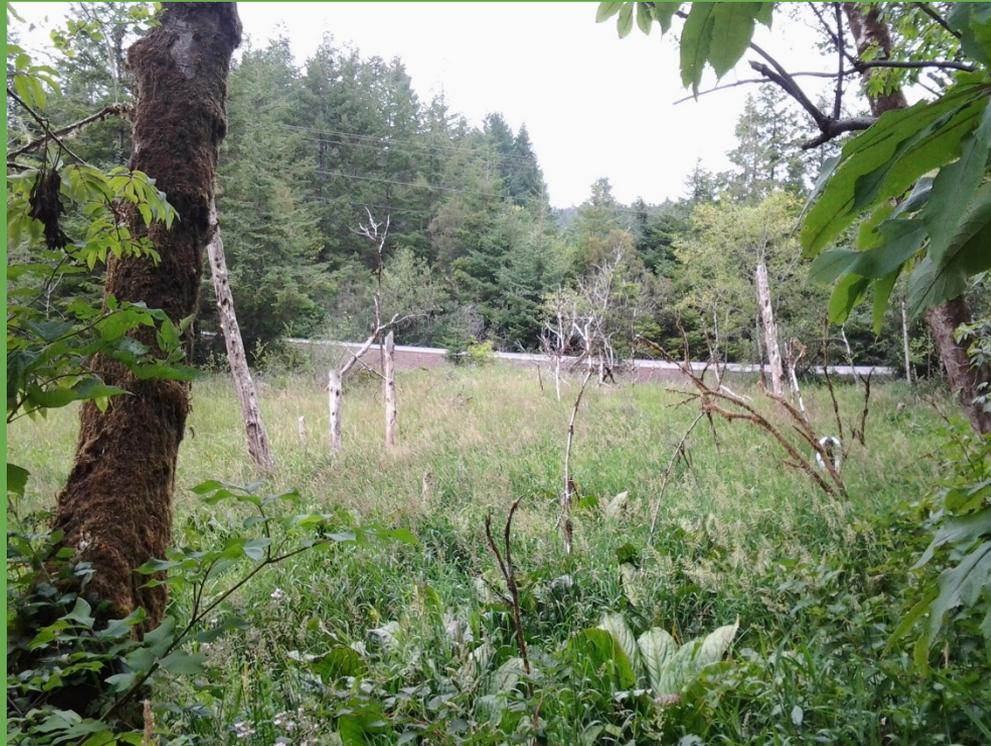
Original Concept, This is what I brought in to odfw

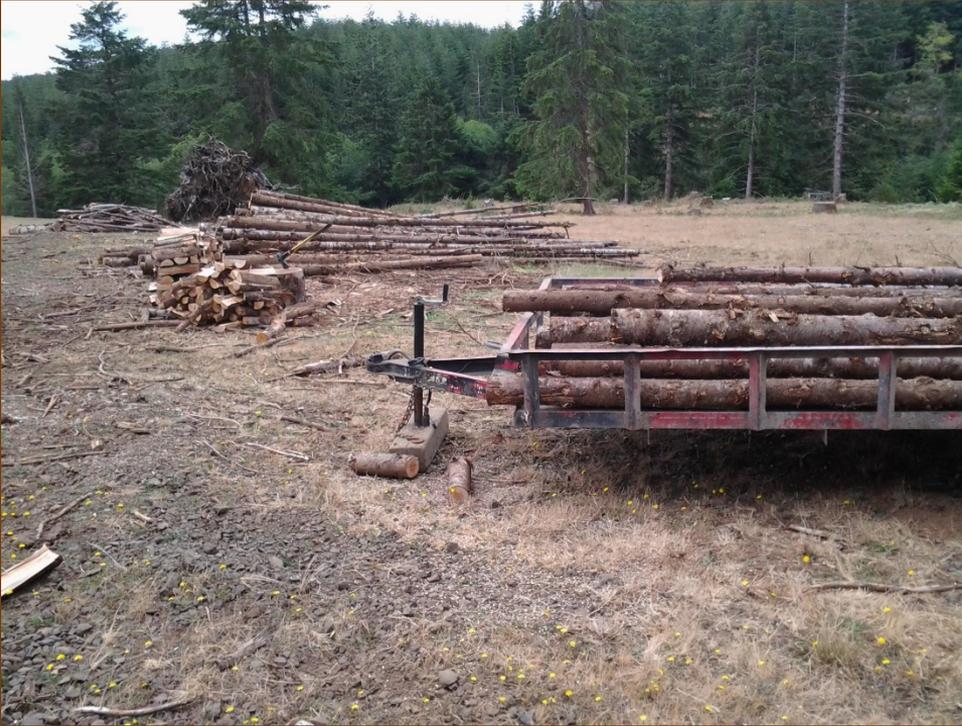
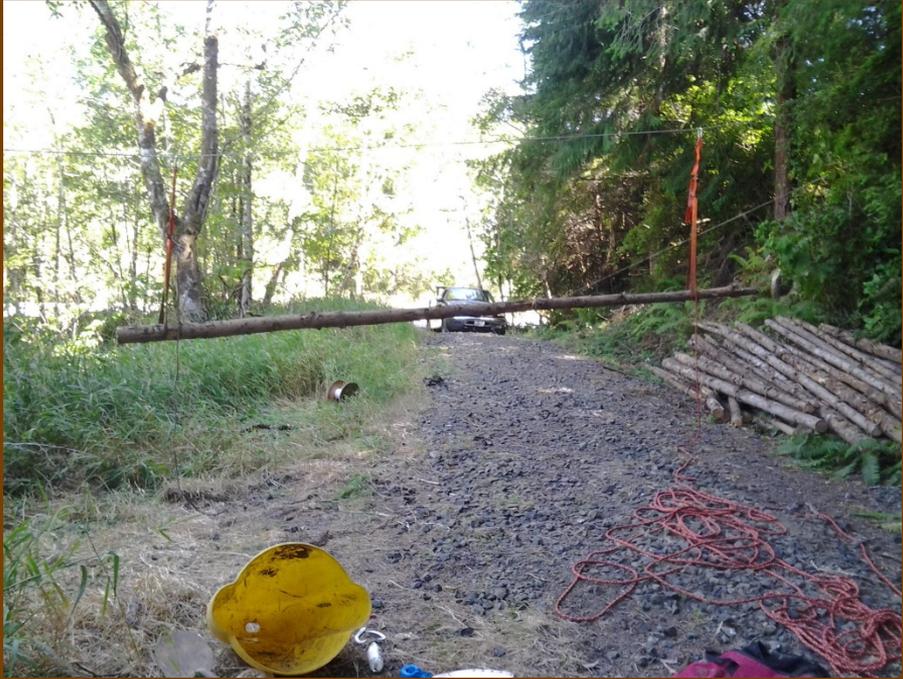
ATV with arch, though cool, took @40 minutes per turn. ATV was also not running well, fire restrictions. No truck access

Capstan winch was also too slow per turn, 10-12 minutes per turn. Left folks standing around.

Poor first 2 days, then 2 solutions

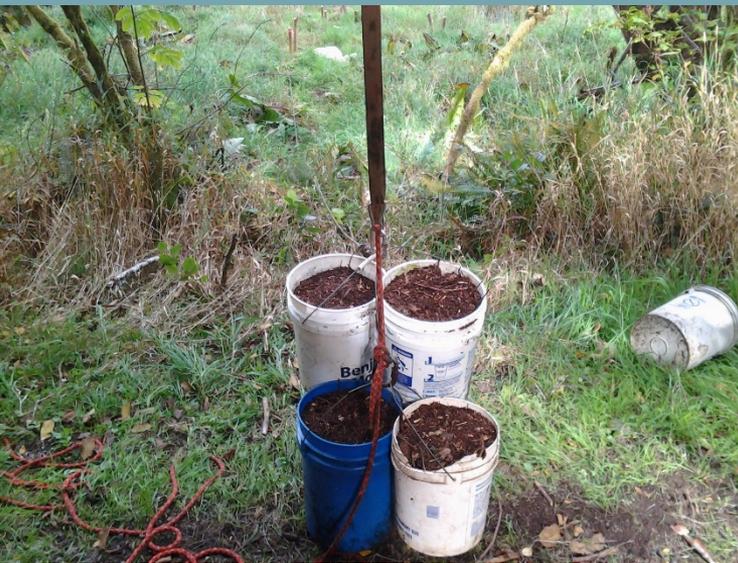
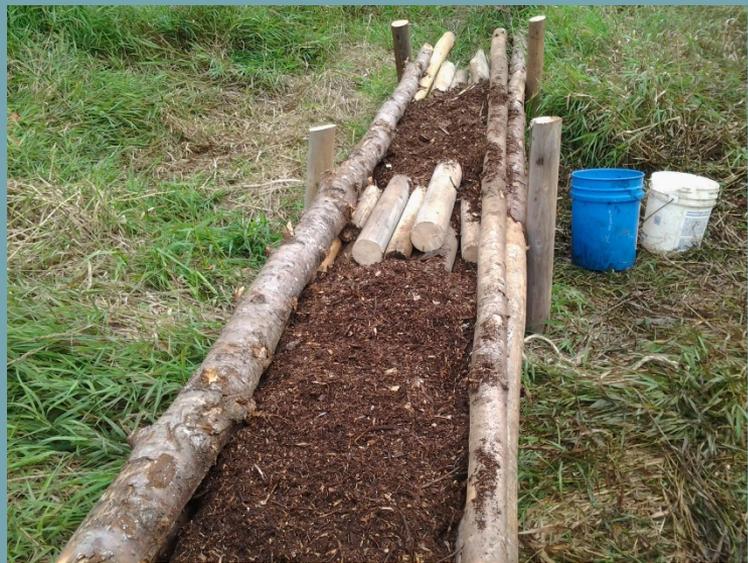
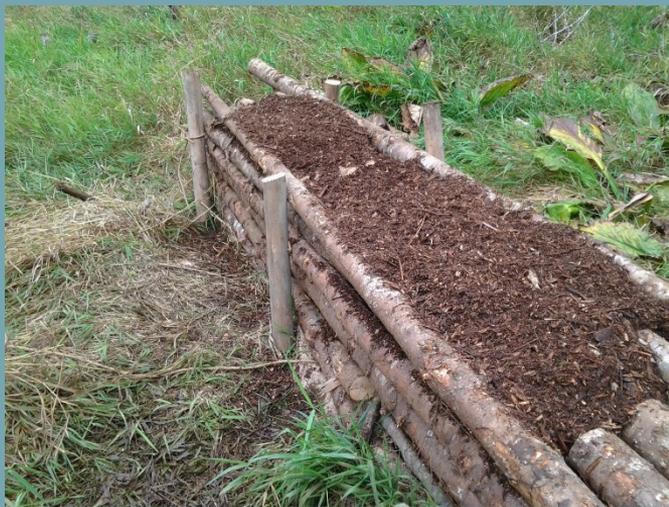
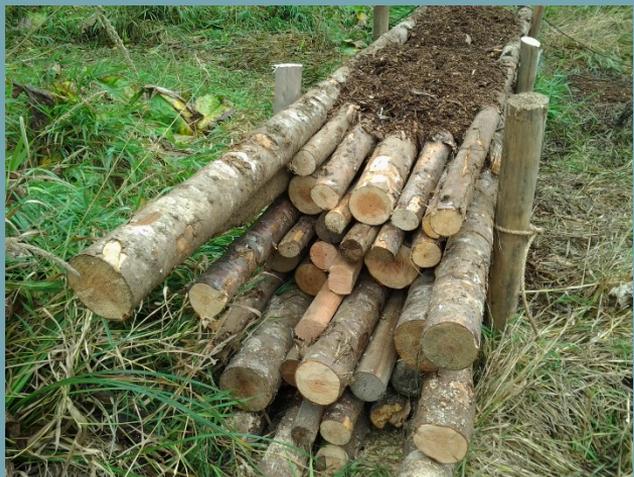
Dec 13, 2015. Coquille goes up to 25'

Water flows over Beaver Hill Rd
and North
Bank Ln

2 Structures disintegrate, logs stay
on site

Others take varying damage, some
none.

Those that were better bundled
with rope
fared the best. Acted just like LWD
with
large limbs.

One day of repair once water went
down.

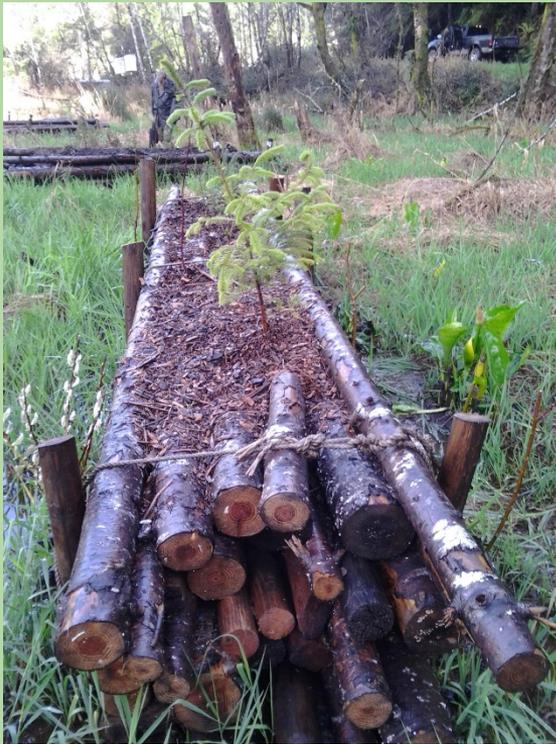
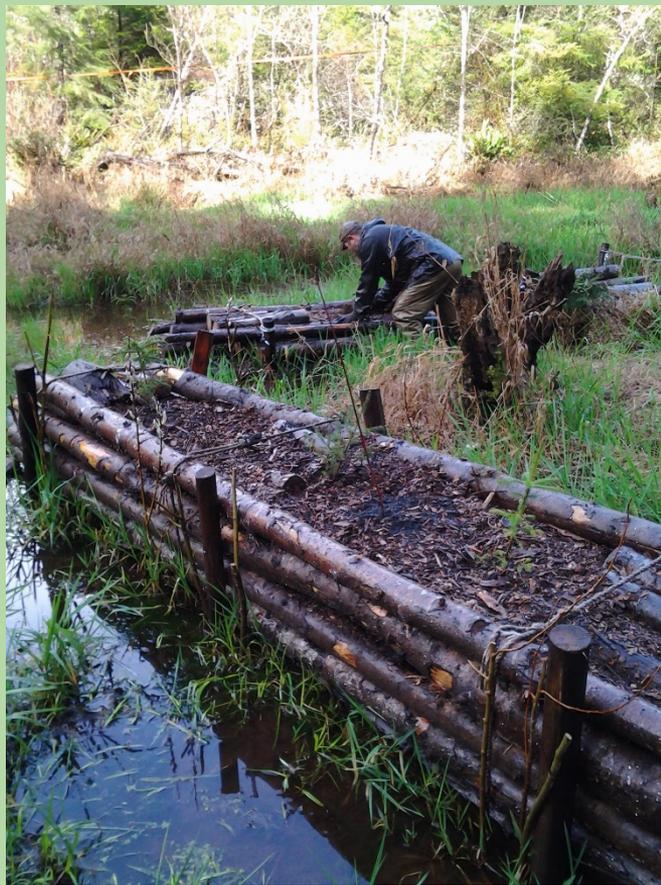
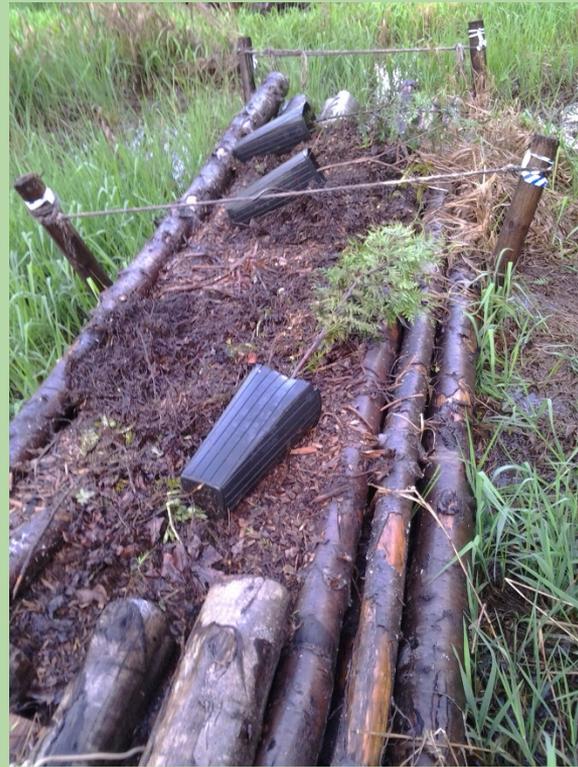
Planted Feb 2016

Sitka Spruce, Red Cedar, Bigleaf Maple, Malus, Twinberry, Willow

Used fewer numbers of larger stock (1&2 gallon). Better chances of survival with larger root mass. Bandon Highschool nursery.

Had to add chips that washed away.

Willow stakes along outsides of structures, will add stability once rooted. Also foot for beaver

Structure were labeled with aluminum tags

Zipline used to get seedlings out into wetland.
